Chapter 2 CONDITION OF THE EXISTING LEGASPI AIRPORT

2.4 EXISTING CONDITIONS OF THE FACILITIES

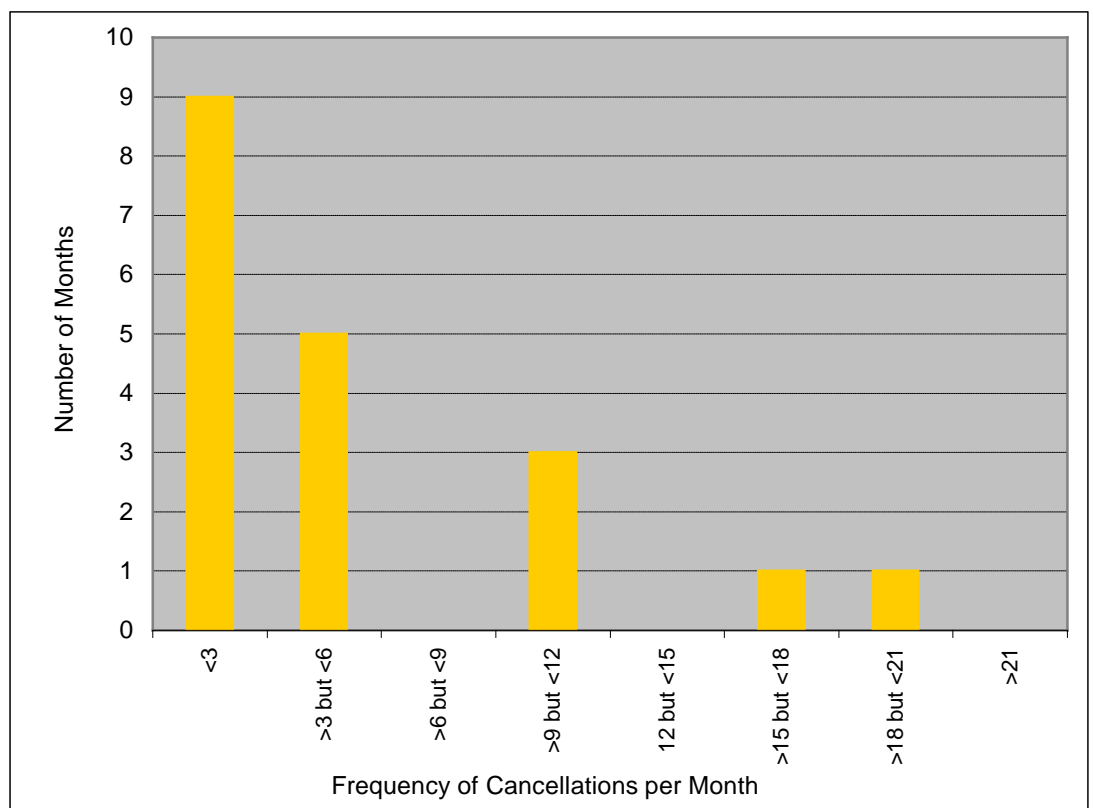
The pattern of flight cancellations at the Legaspi Airport covering a two-year period from 2000-2001 was analyzed. **Figure 2.3-7** shows that nine (9) out of the 24 months observed experienced less than three (3) cancellations. Five of the 24 months experienced three (3) to five (5) cancellations. Over the last two (2) years, the expected number of cancellations per month is computed at 4.0 or an average of 48 cancellations per year.

Fig. 2.3-7 Monthly Flight Cancellation Due to Weather (2000-2001)
